Heritage retrofit and cultural empathy; a discussion of challenges regarding the energy performance of historic UK timber-framed dwellings

Structured Abstract

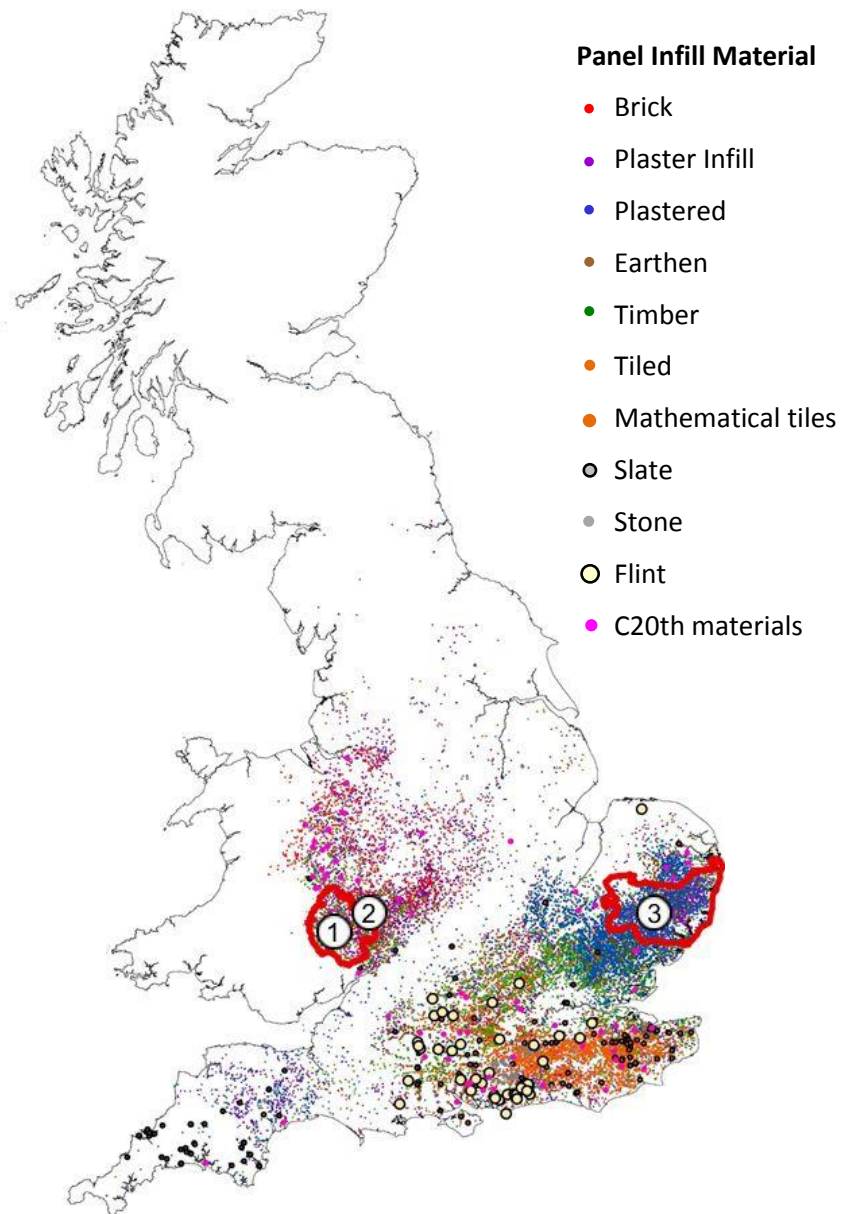
Figure 1. Distribution of timber-framed buildings in Great Britain by infill material, showing location of case studies and associated counties. Source: (Author's own based on data from (Historic England, 2014, RCAHMW, 2014))

The first two case studies (1 & 2) are both located in the county of Herefordshire, in the English West Midlands or Welsh Marches. Figure 1 illustrates that this county encompasses the southwest quadrant of a western concentration of timber-framed buildings in the UK. The predominant panel infill materials in Herefordshire are exposed brick (47%), lime plaster or cement render (44%) and wattle and daub (8%) (Whitman, 2017 p.218). A high

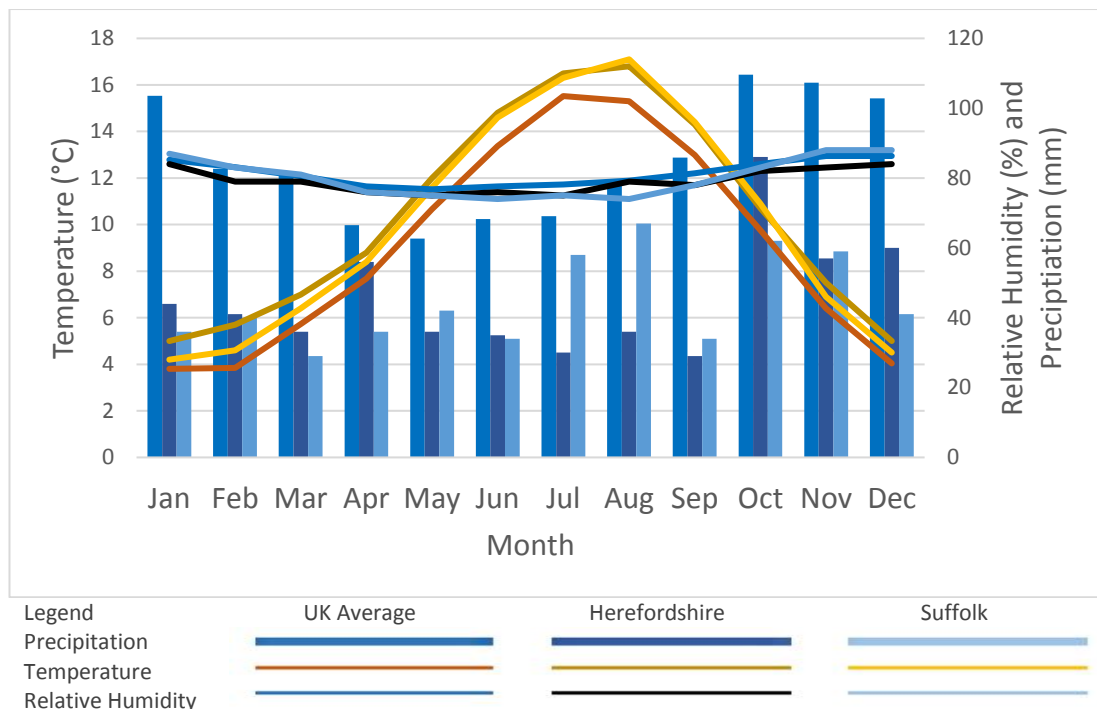
Figure 2 Climatic data for UK, Herefordshire and Suffolk. Source: (Meteotest, 2016, Met. Office, 2009)

The majority of the UK is located in a temperate maritime climate with warm summers and cold winters, classified under the Köppen-Geiger climate classification system as Cfb (C-Warm temperate, f-fully humid, b-warm summers) (Kottek et al., 2006). The heating season typically lasts from November until March with no requirement for mechanical cooling during the summer months. Figure 2 shows the climates for Herefordshire and Suffolk

Both counties share similar temperatures, higher than the UK average. Levels of relative humidity are consistent with the UK average but precipitation is lower. Suffolk receives marginally less (538mm) than Herefordshire (546mm) over the year, however, the pattern of precipitation differs considerably. Suffolk experiences the maximum levels of precipitation during the summer months, the inverse to the UK average, due to the summer thunderstorms that are more common in the east of the country (Manley, 1955 p.262). It should be noted that Herefordshire has a fairly dry climate considering its western location due to the rain shadow of the Welsh Mountains (Phillips, 2013 p.117).

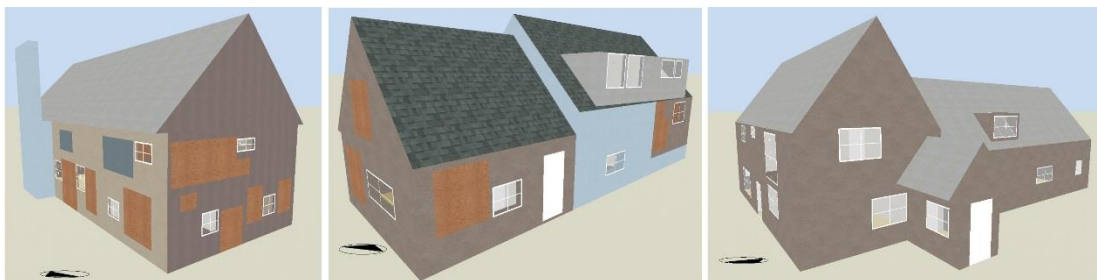
Figure 3. DesignBuilder models of (from left) case studies 1, 2 and 3. Source: (Author's own, 2017)

Simulations were undertaken using the software DesignBuilder Version 4.2.0.54, a graphical interface for the dynamic simulation engine EnergyPlus DLL v8.1.0.009 (Design Builder, 2014). For the building thermal zone calculation, EnergyPlus uses a heat balance model based on the assumption that the air in each building zone is homogenous with no stratification of temperature (Crawley et al., 2001 p.323). The complicated timber-frame was therefore simplified to block sub-surfaces, the area of which accurately represents the area of timber-frame, if not its precise location and configuration (Figure 3).

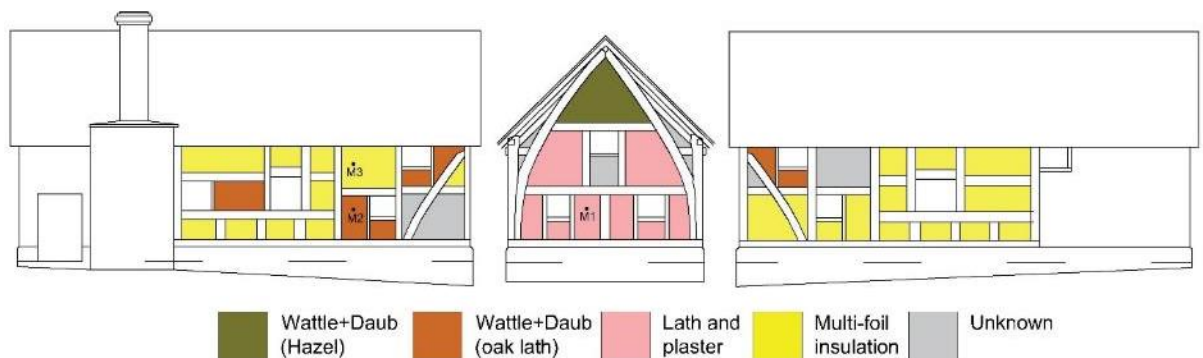
Figure 4 Case study 1. Diagram showing location of each infill panel type. Source: (Author's own, 2016)

Case study 1 is a 15th century cruck hall in the Wye Valley, Herefordshire. For much of the 20th century it lay abandoned and derelict, before being restored 2000 – 2012. It now provides holiday accommodation. The renovation involved three different approaches to wall infill panels, retaining surviving oak lath and lime plaster panels where possible (7% of infill panels by area); new wattle-and-daub panels (18%); and multi-foil insulation (46%), the foil held by upright staves within a void, finished internally and externally with lime plaster on expanded metal lath. The distribution of these panels is shown in Figure 4.

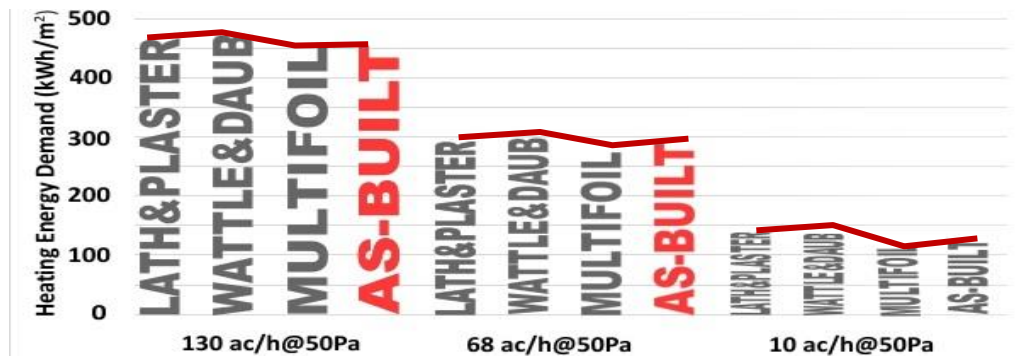
Figure 5. Simulated Heating Energy Demand (kWh/m²) for case study 1. Hypothetical scenarios in grey

Four scenarios of infill panels were simulated using the measured U-values. The first imagined all lath and plaster panels had survived; the second imagined all panels had been replaced with new wattle and daub; the third that all had been replaced with the new multi-foil panels; and the fourth simulated the as-built situation with a mixture of all three

Figure 5 illustrates the high heating demand of this case study, with a building energy index of 455 kWh/m², principally due to the poor airtightness of the building envelope. It can also be seen that the performance of the infill panels has little effect on the heating energy demand with a variation of only +4% and -0.01% when compared to the current situation. However, the simple act of torching the underside of the thatched roof, thereby improving the airtightness, sees a 36% reduction. Further work, such as improving the joints between panel and timber-frame and plugging post-holes could potentially improve the airtightness to a hypothetical 10ac/h@50Pa, thereby achieving a reduction of 72%. Whilst for this specific property no historic fabric was lost in the upgrading of the infill panels, the results of these simulations should have significant weighting in the planning of future retrofits of historic timber-framed buildings.

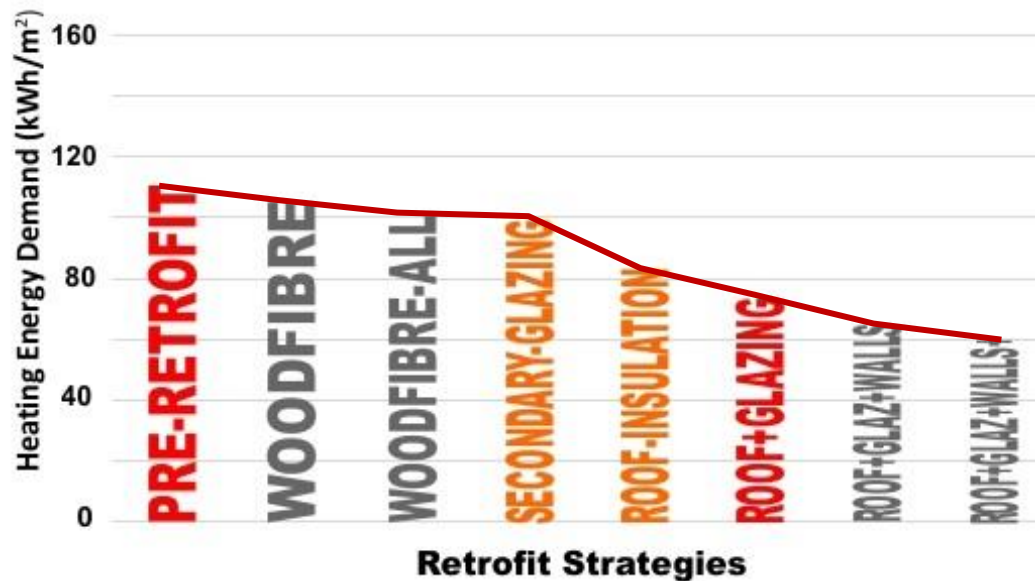
Figure 6. Simulated Heating Energy Demand (kWh/m²) for case study 2. Hypothetical scenarios in grey, individual retrofit actions in orange and as-built in red

The results (Figure 6) demonstrate that the installation of secondary glazing is more effective (10% reduction) than replacing all the infill panels (9% reduction). Whilst it can be argued that secondary glazing is visually intrusive it is however a fully reversible retrofit action and does not result in the loss of historic fabric. The insulating of the roof is the retrofit action with the greatest individual benefit (25% reduction) which when combined with the secondary glazing results in an overall reduction of 34% and is the solution that was applied in reality with a building performance index of 75 kWh/m². It is questionable whether the additional 11% reduction, achievable by replacing all infill panels, would ever be justifiable considering the disruption and potential loss of historic fabric.

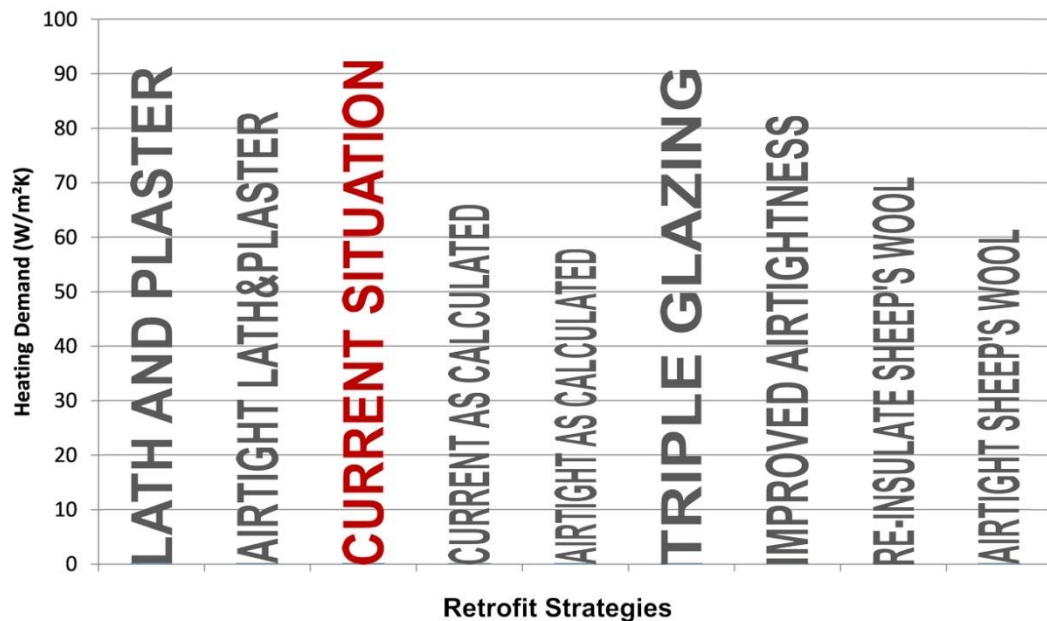
Figure 7. Simulated heating energy demand for case study 3 for a range of hypothetical pre and post-retrofit actions. Existing situation shown in red. Source: (Author's own, 2017)

Figure 7 shows that potentially, prior to the retrofit by the previous owner, the heating demand for the house could have been marginally better (-1%) than the current situation which has a building energy index of 92kWh/m². If the assumption that the original lath and plaster was more airtight than the current detail, then the house may even have been 10% more efficient. Obviously, this was not the intended outcome. If the thermal performance of the walls had achieved their calculated design value of 0.921 W/m²K, then a 26% or 35% reduction in heating energy demand would have been accomplished depending on the airtightness achieved.

The replacement of all windows with triple glazing makes little difference to the heating energy demand with the simulation results showing only a 2% reduction. This is to be expected, as most of the windows are already double glazed units in modern timber frames.
